Manhole Inspection Summary

Manhole # S06GG2007MH

Location Address: **3504 WALLIS AVE**

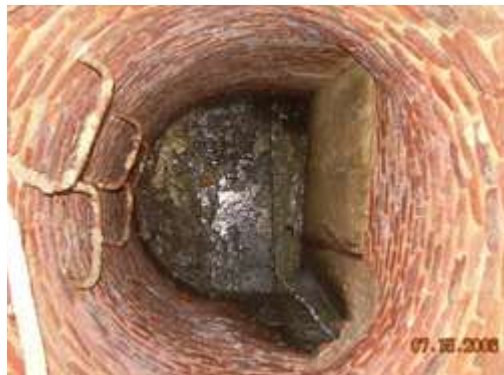
Top View

Adjustment and Corbel infiltration. Barrel root intrusion and infiltration. Bench and Channel debris. Corroded steps.

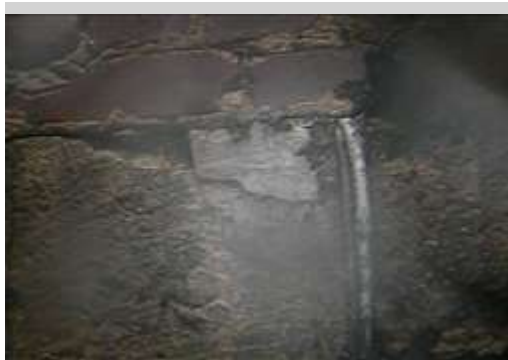
Defect

Condition: ☐ Sound ☐ Cracked ☒ **Root Intrusion** ☐ Loose Brick ☐ Deteriorated

Infiltration: ☐ None ☒ **Joint** ☐ Cracks ☒ **Mortar** ☒ **Roots** ☒ **Wall**

Barrel root intrusion and infiltration.

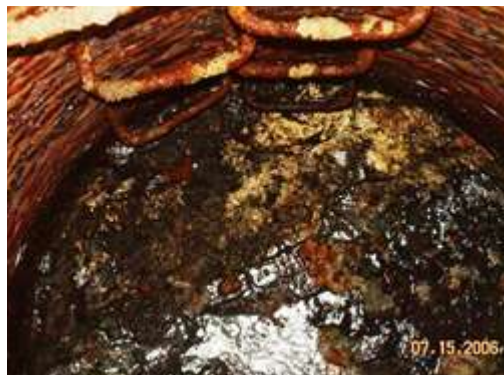
Defect

Count: **8** Missing: **0** ☒ **Corroded**

Corroded steps. Bench debris.

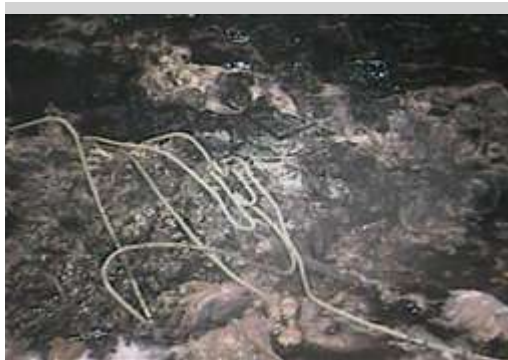
Defect

Comments **Recommend installing drop connection in the 5 o' clock position. There is heavy debris on the bench due to the height of the I5.**

Bench and Channel debris.

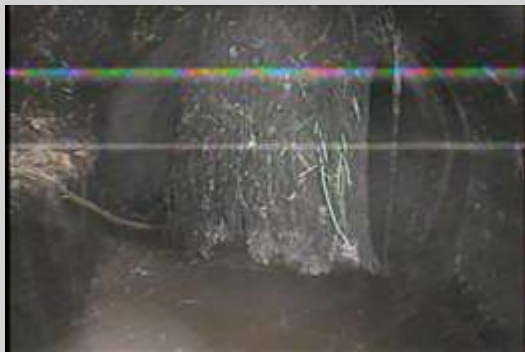
18 in. Circular Gravity Sewer Pipe Out @ 12 O'Clock

Barrel root intrusion and infiltration.

Infiltration: **Evidence** Pipe Seal Cond: **Roots**
